# PROGRAM FOR ESTABLISHING LONG-TIME FLIGHT SERVICE PERFORMANCE OF COMPOSITE MATERIALS IN THE CENTER WING STRUCTURE OF C-130 AIRCRAFT

## PHASE V — FLIGHT SERVICE AND INSPECTION

J. A. KIZER

LOCKHEED-GEORGIA COMPANY  
Marietta, Georgia 30063

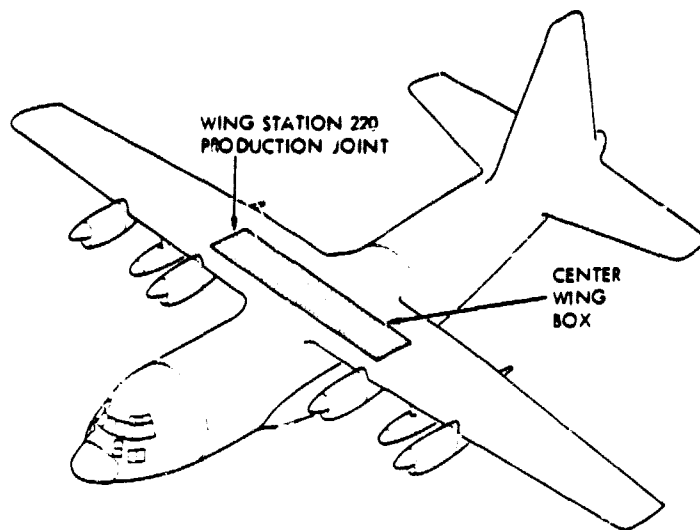
Figure 2. C-130 Center Wing Box Locations

The center wing box size and location in the C-130 aircraft are illustrated in Figure 2. It is 11.2 m (440 in.) in length, 2.03 m (80 in.) in chord and, in the all-metal configurations, weighs approximately 2243 kg (4944 lb). The center wing box consists of upper and lower surfaces that are reinforced with hat-shaped stringers, the forward and aft wing beams, and truss-type ribs.

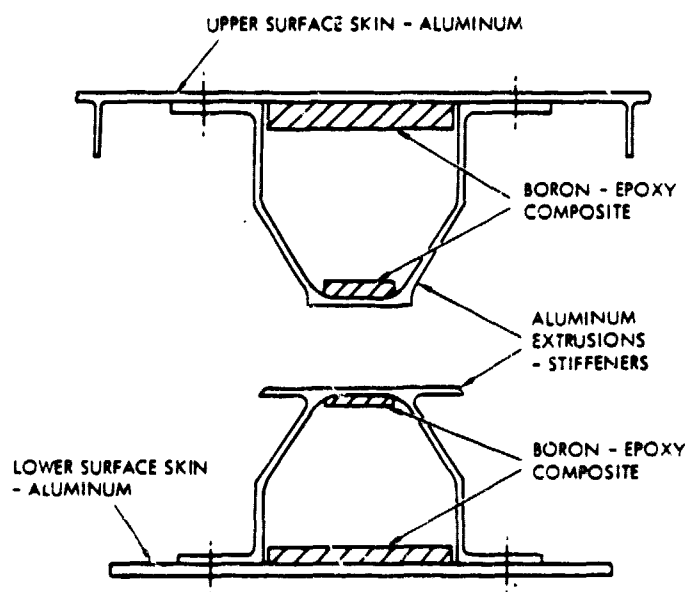
Figure 3. Composite Reinforcement Concept

Cross-sections of the boron-epoxy reinforced center wing structure are shown in Figure 3 for both upper and lower wing surface panels. Note that the boron-epoxy reinforcements will not be visible to the inspector and that the contact ultrasonic inspection will be performed with the ultrasonic equipment transducer in contact with the aluminum structure (i.e., aluminum skin or aluminum hat-section stringer). The boron-epoxy reinforcements are located at stringers number 1 through number 11 of the center wing upper surface and at stringers number 12 through number 24 of the center wing lower surface. All boron-epoxy reinforcement straps are unidirectional laminates that were cured before they were bonded to the aluminum wing surface skins and aluminum hat-section stringers.

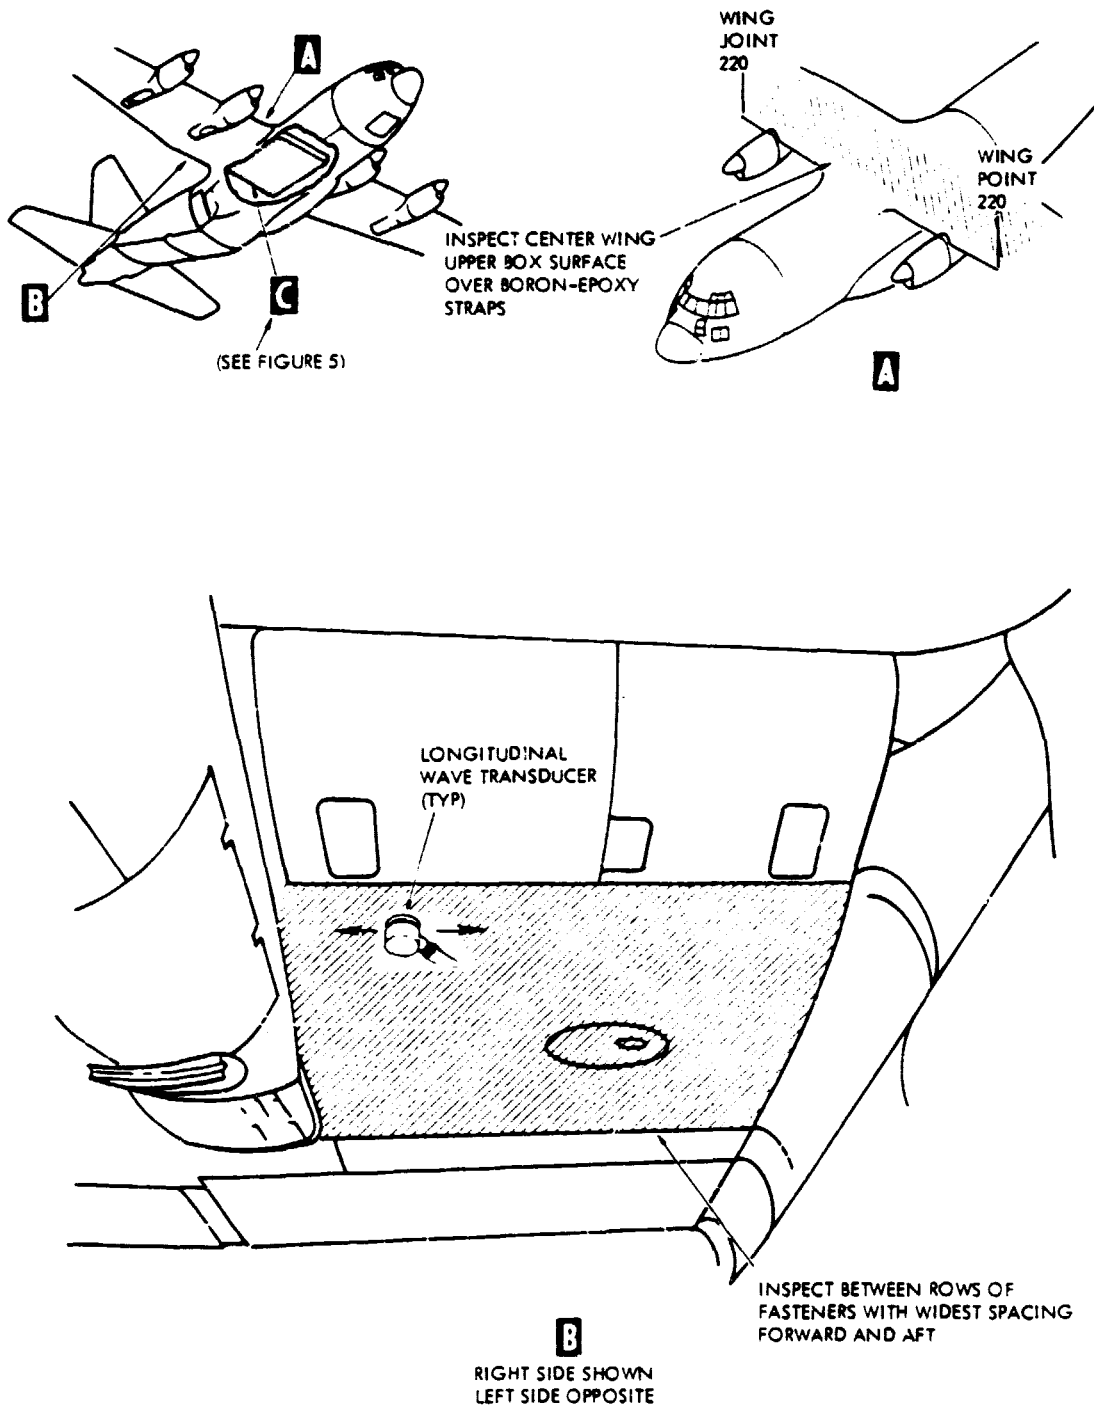
Figure 4. Exterior Areas of Boron-Epoxy Reinforced Center Wing to be Inspected

Figures 4 and 5 show the areas of the boron-epoxy reinforced center wing section to be inspected. Figure 4 shows the exterior surface areas to be inspected, and Figure 5 shows accessible interior areas to be inspected. Note that the access door located on the upper surface of the center wing will have to be removed to gain access to the dry bay area to inspect the hat-section stiffener/boron-epoxy reinforcement bondlines. It is further noted that fuel bladder cells have to be removed to have total access to all boron-epoxy reinforcements.

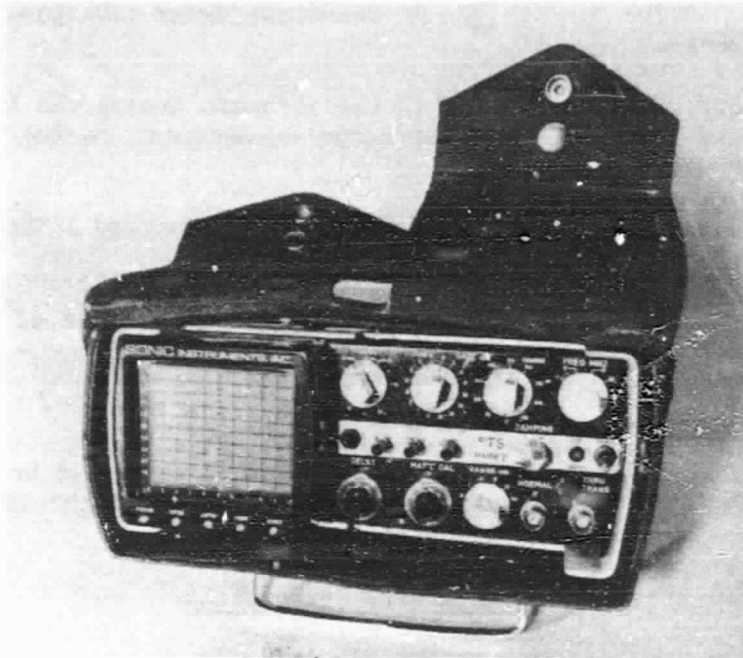
Figure 6. Sonic Mark I Flaw Detector

The Sonic Mark I Flaw Detector or the Sperry UM715 Reflectoscope, or equivalent, may be used to ultrasonically inspect the boron-epoxy reinforced center wing structure. The Sonic Mark I Flaw Detector is shown in Figure 6, and the UM715 Reflectoscope is depicted in Figure 7. In the early inspections conducted on the boron-epoxy reinforced center wing boxes, the Magnaflux PS702 Flaw Detector was used. However, later inspections were conducted with the newer Sonic Mark I and Sonic Mark IV Flaw Detectors.

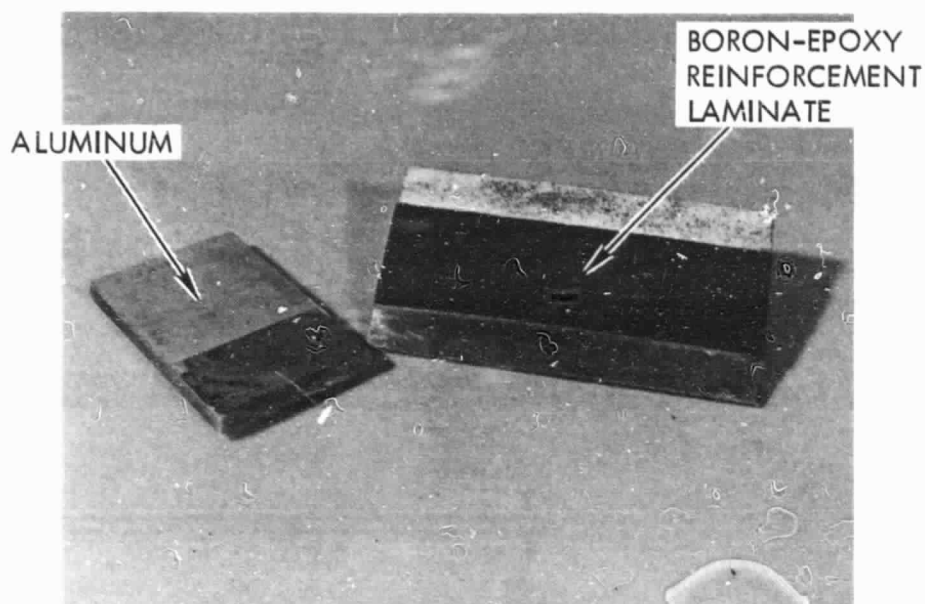
Figure 8. Calibration Standards for Contact Ultrasonic Equipment

Calibration standards for calibrating the contact ultrasonic equipment are shown in Figure 8.

The smaller of the two standards in Figure 8 was used for calibrating the contact ultrasonic equipment for inspecting the boron-epoxy-laminate/hat-section stringer crown bondlines. The larger of the two standards shown in Figure 8 was

used for calibrating the contact ultrasonic equipment for inspecting the boron-epoxy laminate/aluminum wing surface skin bondlines. This larger standard includes an area for calibration of the ultrasonic equipment for inspection of the walkway region of the upper wing surface as that region includes a non-skid coating that is thicker than the finish systems in other areas of the exterior wing surfaces. Figures 9 and 10 are engineering drawings of the two calibration standards shown in Figure 8. In Figure 9, the dimensions and materials are defined for fabricating the calibration standard for the boron-epoxy reinforcement laminate/aluminum wing surface skin bondlines. Figure 10 gives the dimensions and materials required for fabricating the calibration standard for the boron-epoxy reinforcement laminate/hat-section stringer crown bondlines.

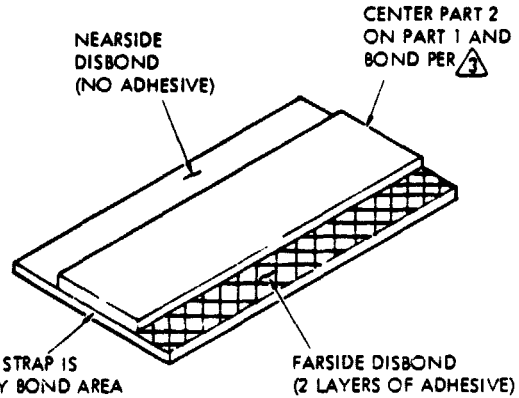
Figure 9. Calibration Standard for Boron-Epoxy Reinforcement/Aluminum Skin Bondlines

Calibration of the ultrasonic inspection equipment will be accomplished with the appropriate calibration standard shown in either Figures 9 or 10. The calibration standard shown in Figure 9 may be used to calibrate for either painted or unpainted single bondlines. The contact ultrasonic equipment will be calibrated as follows:

- ⚠ FOR ALUMINUM PARTS; SULFURIC ACID ANODIZE PER MIL-A-8625, TYPE II. SPRAY ONE COAT WASH PRIMER, MIL-C-8514, AND 2 COATS ZINC CHROMATE PRIMER, TT-P-1757.
- ⚠ ON PART 1; BRUSH APPLY WALKWAY COATING, MIL-W-5044 IN AREA "A". (COLOR NOT IMPORTANT).
- ⚠ BOND BORON-EPOXY TO ALUMINUM WITH AF127-3 ADHESIVE FOR A MINIMUM CURE CYCLE OF FOUR HOURS AT  $366^{\circ} \pm 5.6^{\circ} \text{K}$  ( $200^{\circ} \pm 10^{\circ} \text{F}$ )

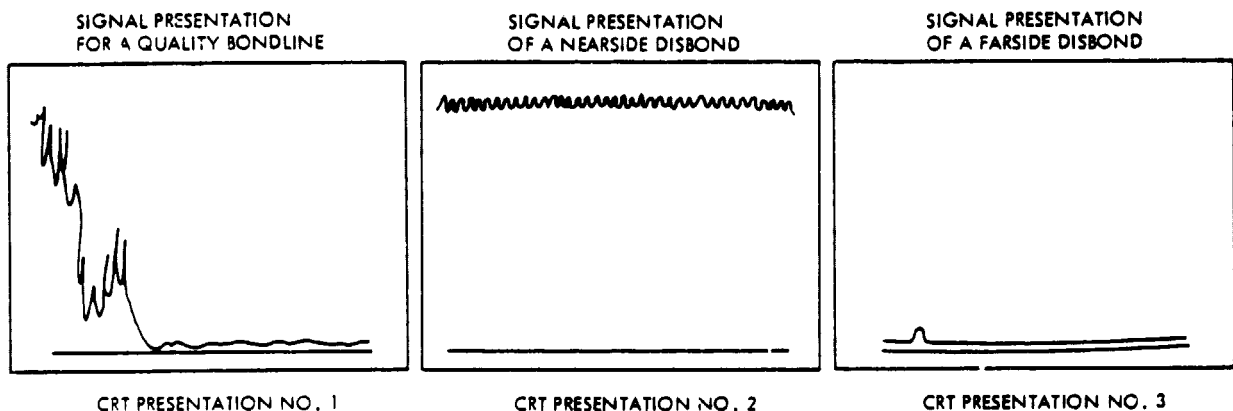
Figure 11. CRT Signal Presentations for Bondline Conditions

3. Adjust sweep of the ultrasonic flaw detector to obtain a signal occupying approximately 50 percent of the cathode ray tube (CRT) screen. The signal for a quality bondline is shown in CRT Presentation No. 1 of Figure 11.

4. Place transducer over the nearside disbond area of the calibration standard.
5. Adjust the sweep delay/length controls of the flaw detector unit to obtain a ringing signal as shown in CRT Presentation No. 2 of Figure 11.

6. Place transducer over the farside disbond area of the calibration standard.
7. Adjust the sweep delay/length controls of the flaw detector unit to move all signals off the CRT screen as shown in CRT Presentation No. 3 of Figure 11.

8. Balance the gain and sweep controls until the nearside disbond rings out 100 percent, the good quality area covers approximately 50 percent of the CRT screen, and no signal is apparent on the CRT screen for farside disbonds, as illustrated in Figure 11.

3. Scan the bonded areas of the boron-epoxy reinforced center wing, slowly moving the transducer over the bonded areas while observing the signal presentations on the CRT screen of the flaw detector. It is noted that while inspecting the boron-epoxy reinforced center wing, it is possible to check the calibration of the ultrasonic equipment. This may be accomplished by scanning several areas of the wing surface and observing the signal presentations on the CRT screen. For example, when the transducer is located over wing surface skin between hat-section stringers, the signal presentation on the CRT screen should appear as a nearside disbond as shown in Figure 11. When the transducer is located over an adhesive "squeeze out" area as depicted in Figure 14, the signal presentation on the CRT screen should appear as a farside disbond as shown in Figure 11.

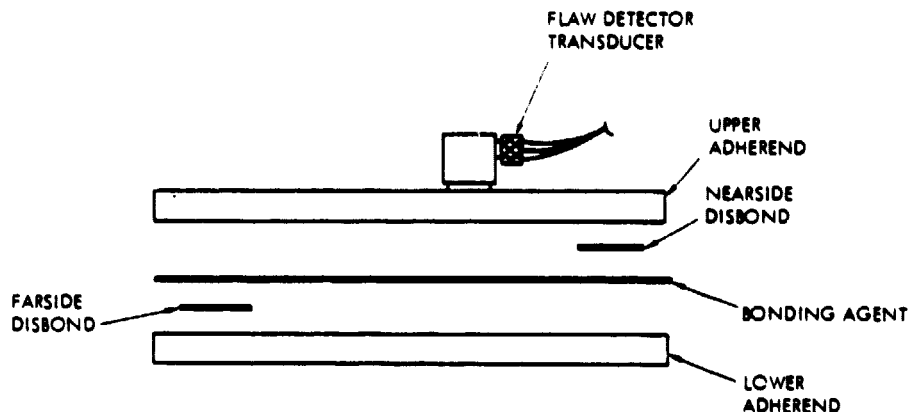
Figure 12. Definition of Nearside and Farside Disbonds

Definitions of nearside and farside disbonds are presented in Figure 12. The terminology of "nearside" and "farside" relates to the location of the flaw detector transducer in relation to the location of the disbond.

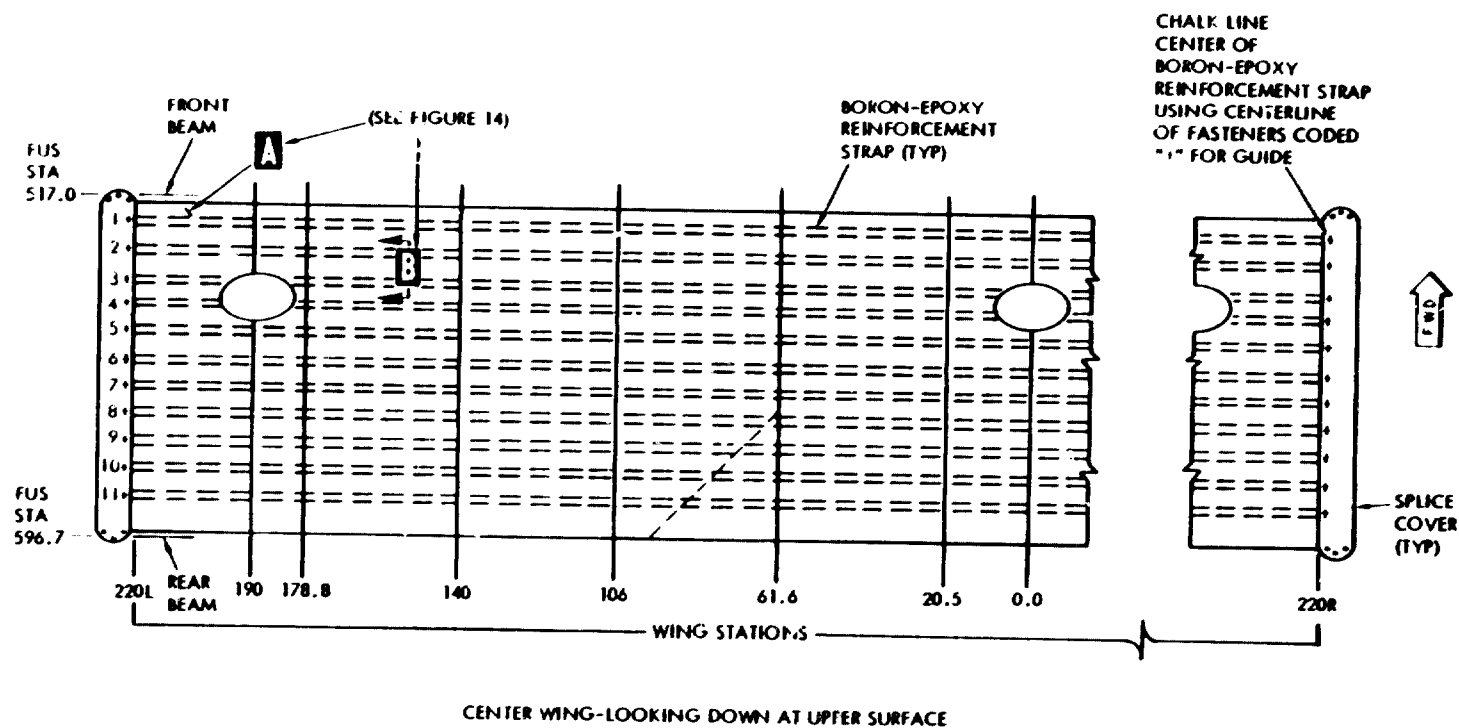
Figure 13. Center Wing Upper Surface Bondline Locations

1. Locate the boron-epoxy reinforcement to upper wing surface bondlines and mark exterior wing surface with chalk lines as shown in Figure 13.
2. Apply couplant to the exterior surface of the upper center wing skin on areas along chalk lines as shown in Figure 14. Also, apply couplant to the accessible exterior surfaces of the crowns of the hat-section stringers as shown in Figure 14.

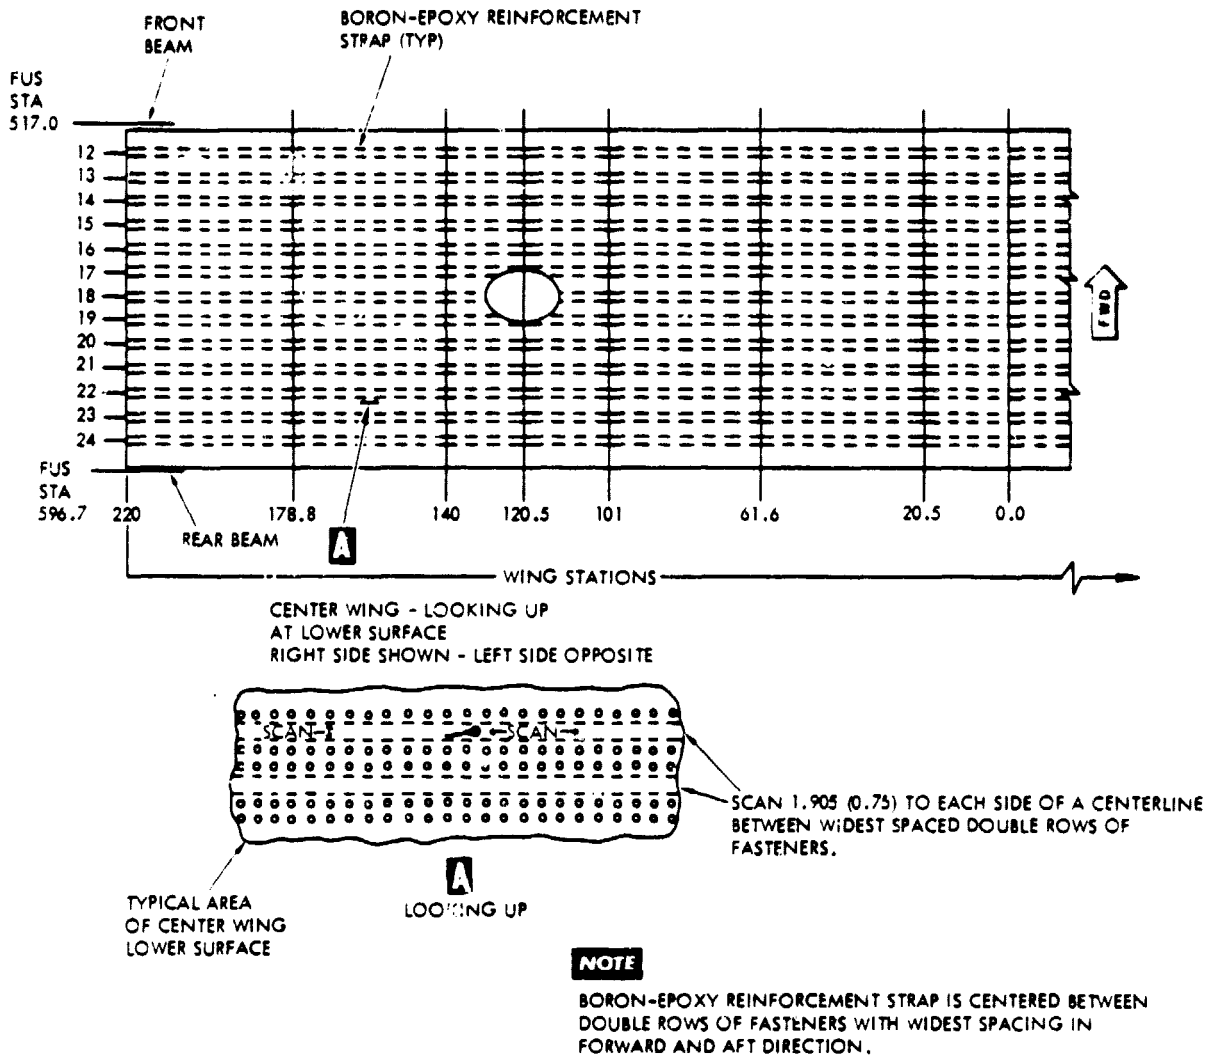
Figure 15. Center Wing Lower Surface Bondline Locations

4. Locate the boron-epoxy reinforcement to lower wing surface bondlines by identifying the widest spaces between double rows of fasteners as shown in Figure 15.

5. Apply couplant to the exterior surface of the lower wing skin on the areas between rows of fasteners described in 4 above. Also apply couplant to the accessible exterior surfaces of the crowns of the hat-section stringers attached to the lower center wing skin.
6. Scan the bonded areas of the lower center wing surface assembly slowly moving the transducer over the bonded areas while observing the signal presentations on the CRT screen of the flaw detector.

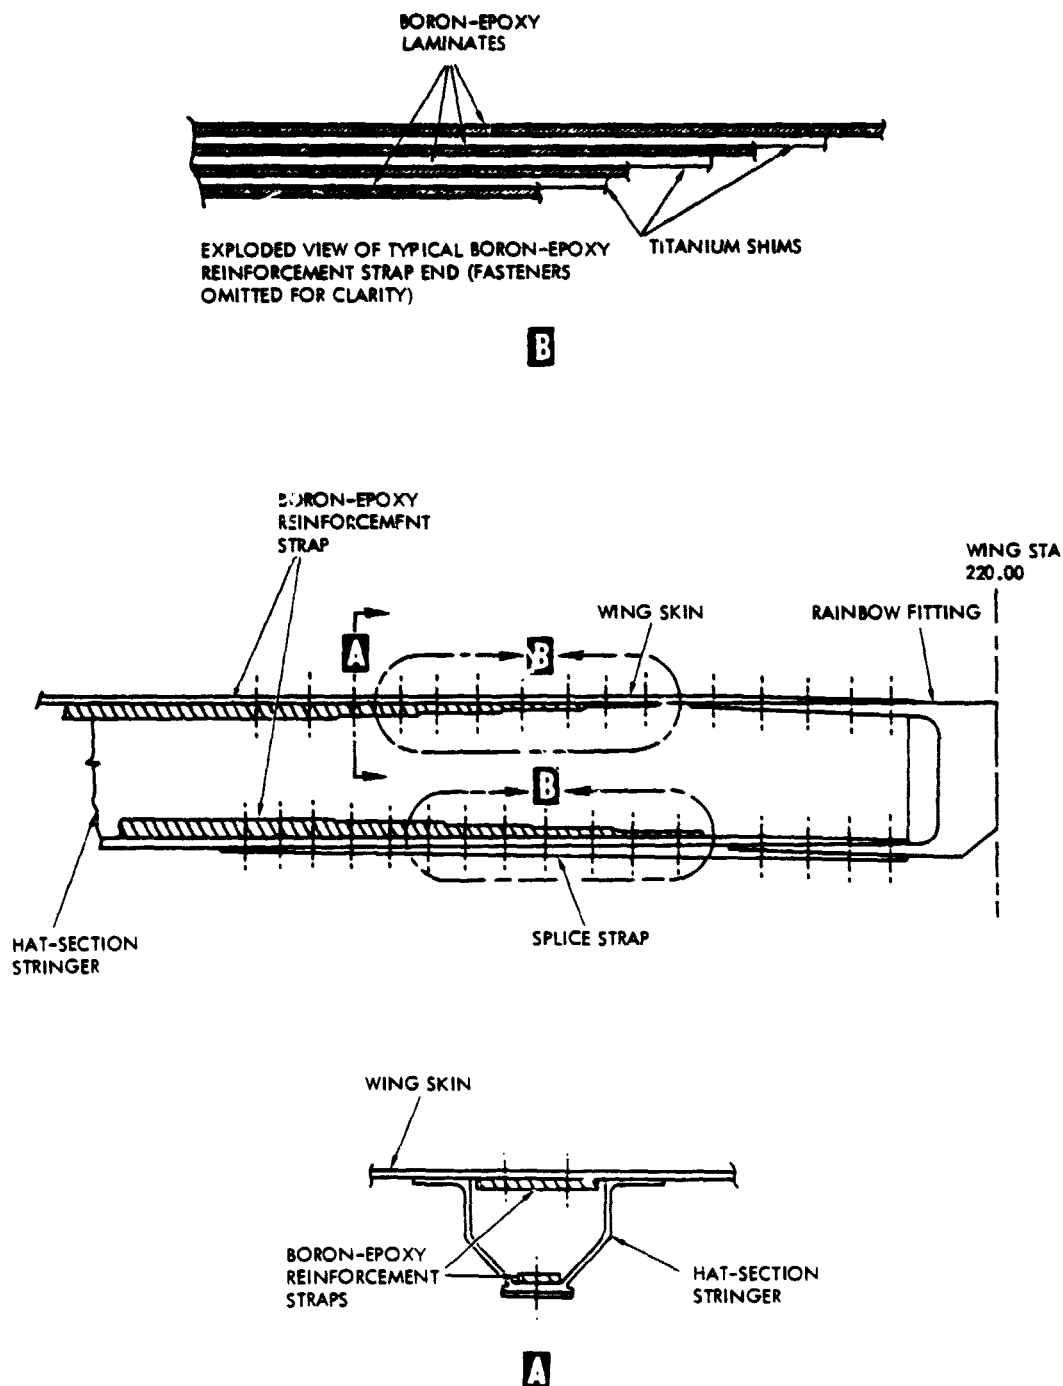
Figure 16. Typical Wing Station 220 Joint Area Configuration

The boron-epoxy reinforcement straps (laminates) are reduced in thickness at the ends of each strap. The reductions in thickness are accomplished by using subsequent boron-epoxy laminate plies of shorter lengths. In these reduced regions, the boron-epoxy laminate plies are interleaved with titanium shims as shown in Figure 16. The reduced cross-sectional areas at the ends of the boron-epoxy reinforcement straps will have a slight effect on the quality signal obtained during the ultrasonic inspection. As the reinforcement strap tapers in thickness, movement of the ultrasonic transducers along the tapered strap will result in a gradual change in the amplitude of the CRT signal. Thus, a different calibration standard is not required as comparison between the slightly changed quality signal and the disbond signal may be made along the tapered strap with the appropriate CRT presentations in Figure 11. Fasteners are installed in the boron-epoxy reduced thickness regions as shown in Figure 16 to resist any peeling force on boron-epoxy reinforcement strap to metal surface bondlines. The installation of fasteners in these regions has no effect on the ultrasonic inspection of the boron-epoxy reinforcement strap/aluminum structure bondlines other than reducing the area of the bondlines. In summary, both reduced area boron-epoxy reinforcement straps and fastener installations were evaluated during development of the ultrasonic inspection procedures and it was determined that the slight variations in CRT signal did not warrant fabrication of additional calibration standards.
